The environmental impact of service life-extending repair for corrosion damaged reinforced concrete balconies: a case study in a coastal context

Neel Renne, Bart Craeye, Matthias Buyle and Amaryllis Audenaert

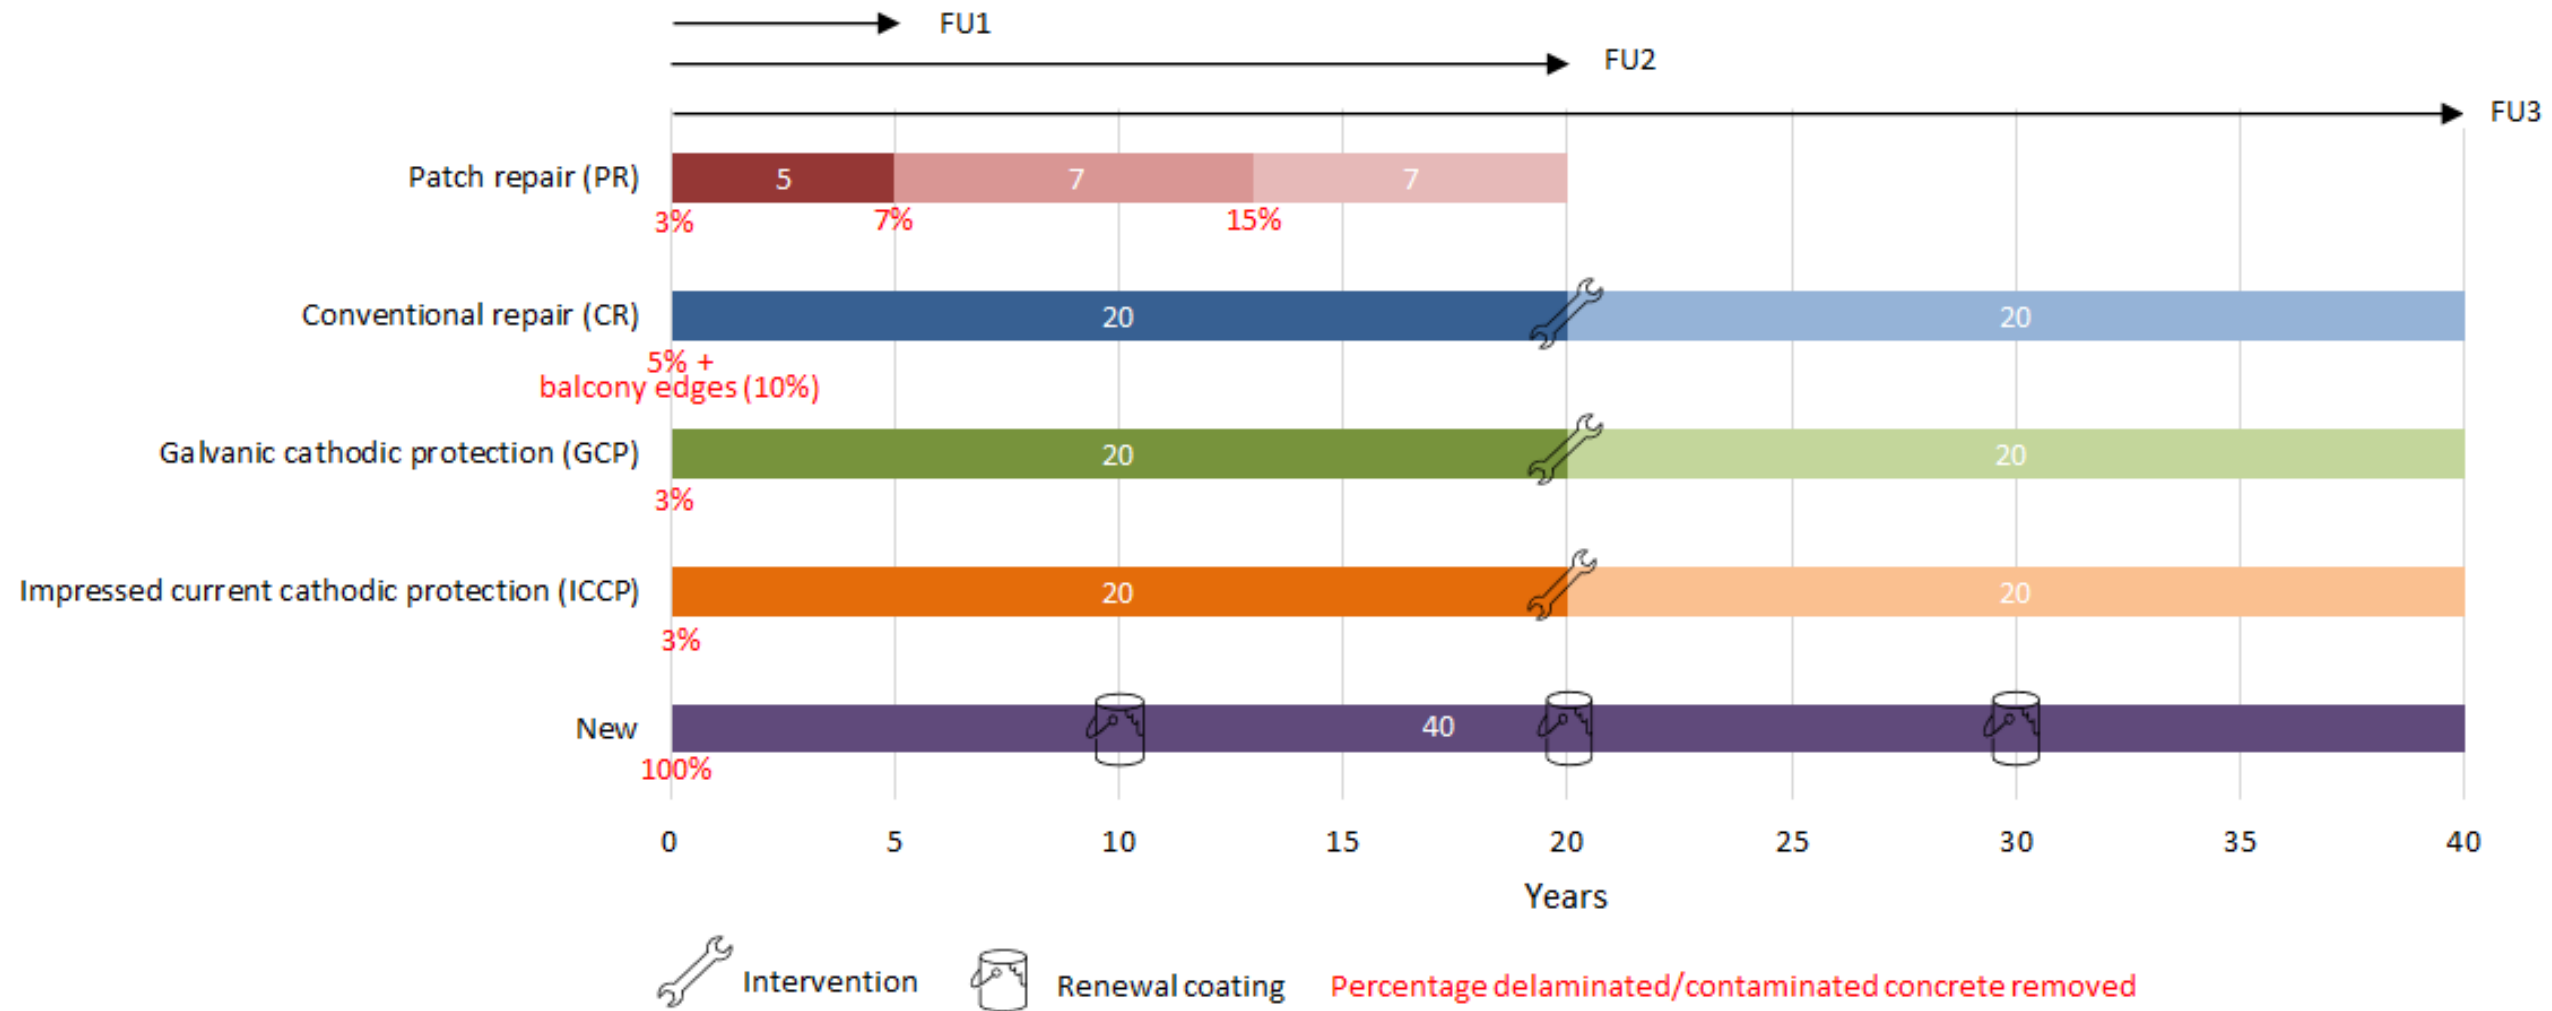
Methodology

- **Corrosion:** propagation started, without affecting load bearing capacity
- **Intensity damage:** rating cfr. paper B. Craeye ICCRRR*
- **3 Functional units (FU):** the service life extension of 20 balconies for 5, 20 and 40 years
- **Building:** 10 floors with 2 individual balconies on each floor
- **Dimensions:** 1 m x 2 m × 0.1 m & a double steel mesh 8/8/150/150 mm
- **Consequential approach:** flows described as response to possible decisions
- **Ecoinvent database v3.5**
- **ReCiPe 2016 v1.04 method:** midpoints & endpoints

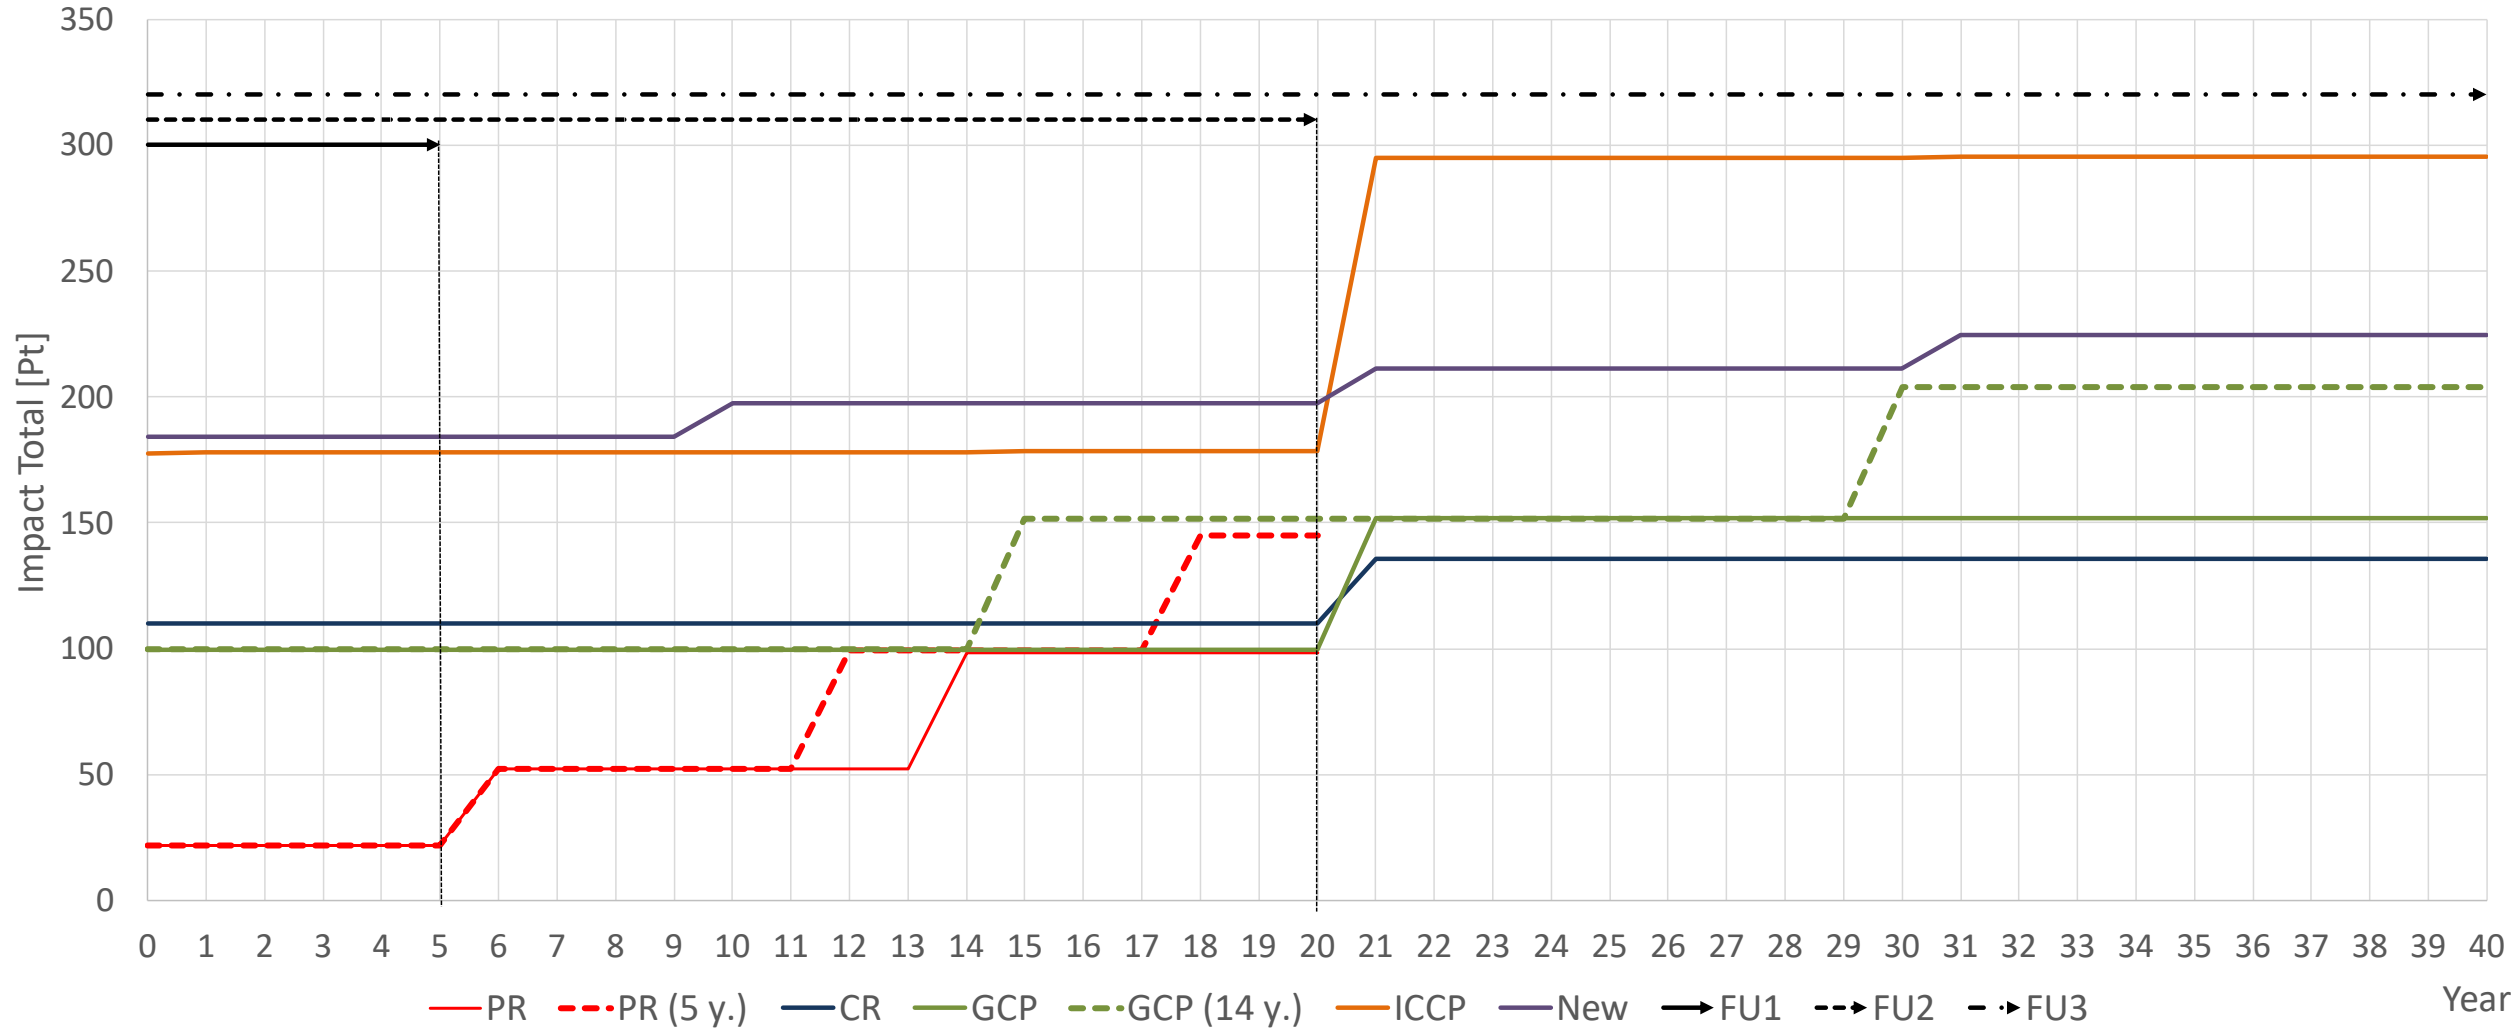
SA2: Intended service life extension

SA2: influence service life PR & GCP (Total Impact [Pt])

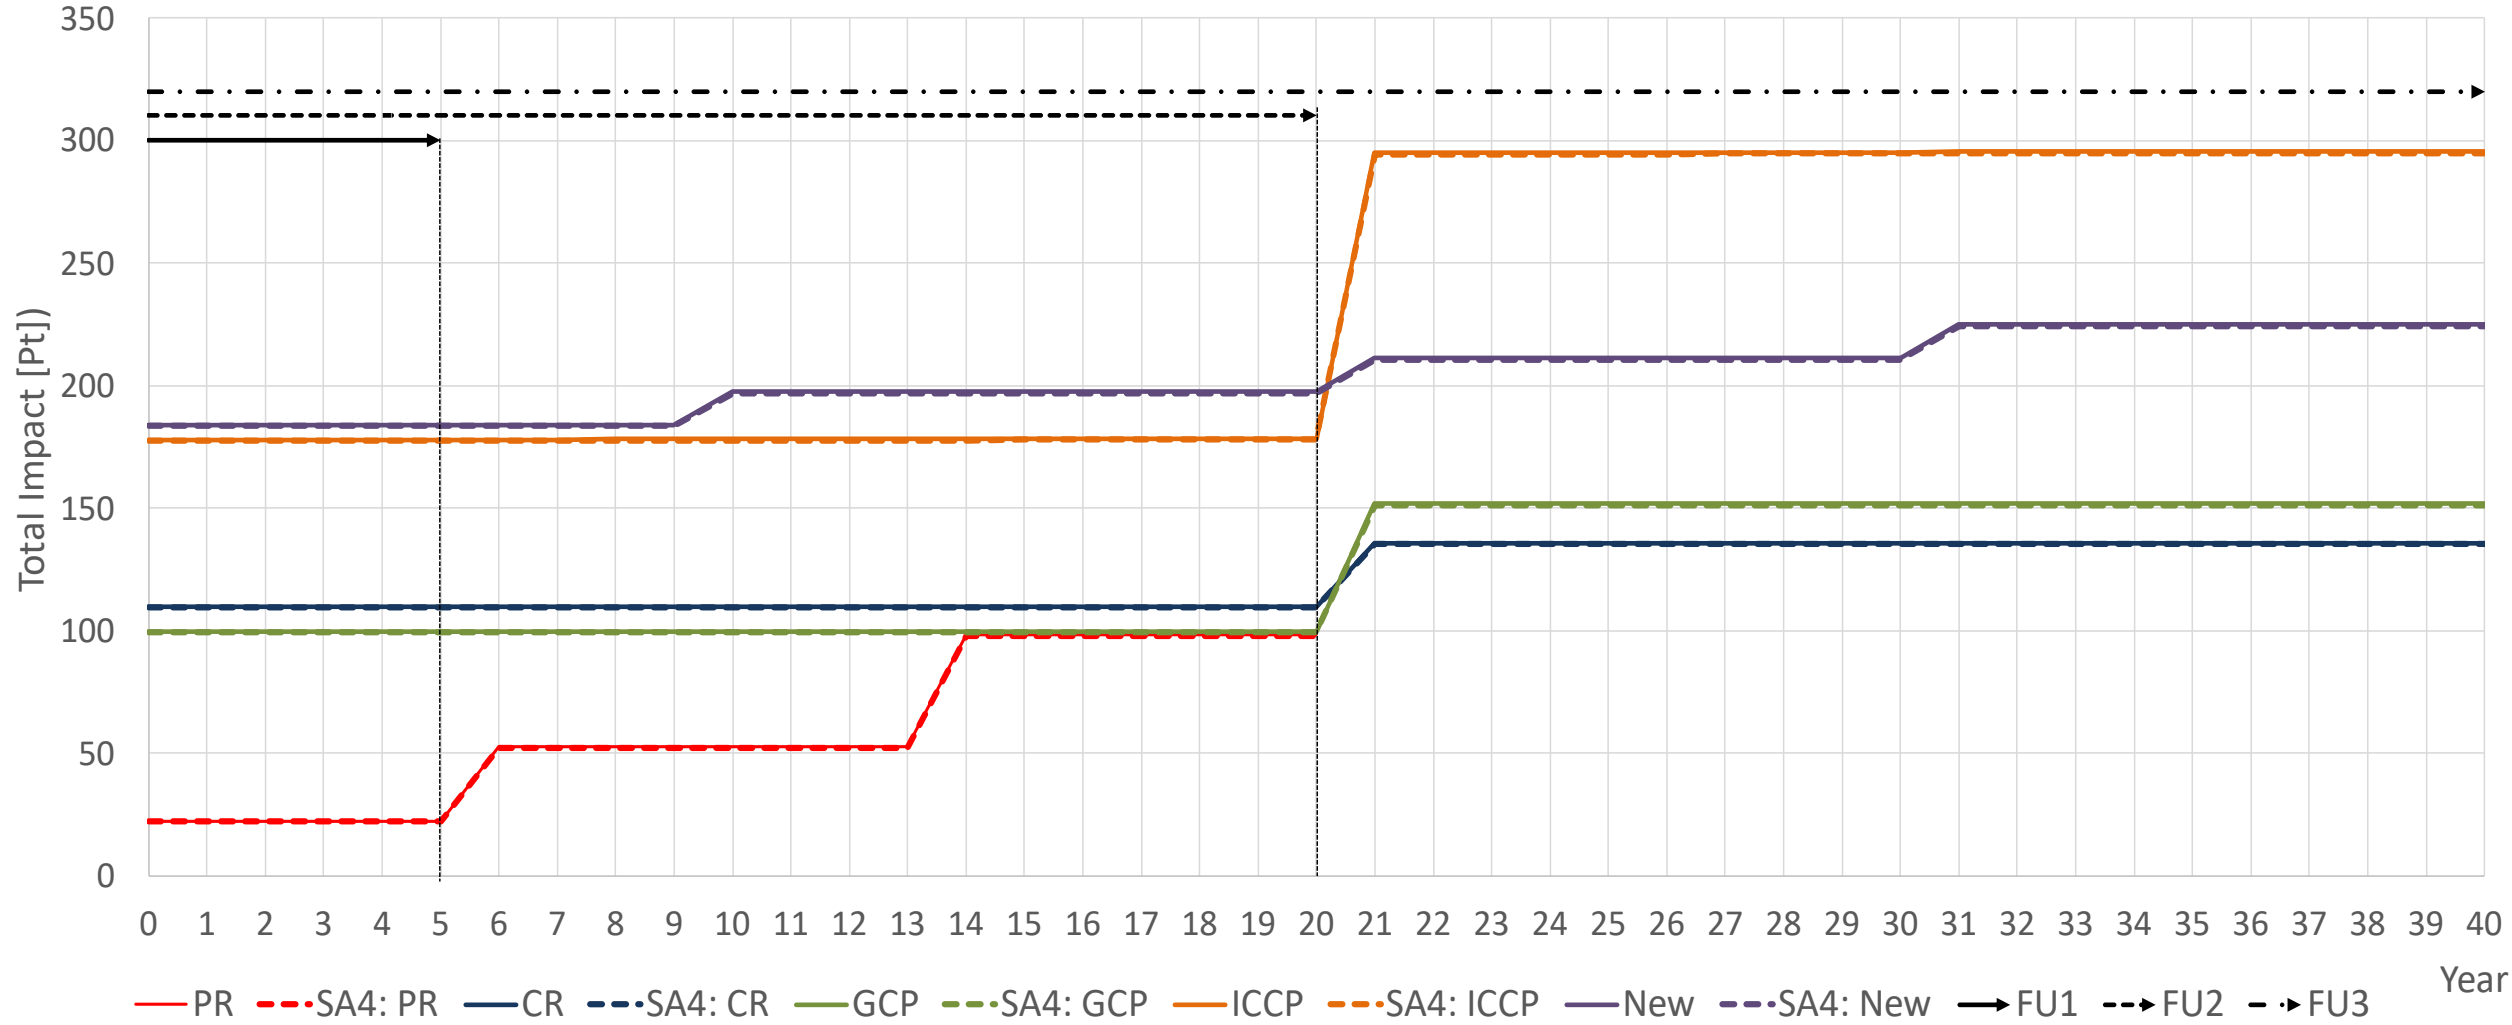
SA4: Composition of coating/waterproofing

SA4: composition concrete coating/waterproofing (Total Impact [Pt])
